SHIPWRECK WORK CONTINUES ON BANKS OF THE ASHLEY RIVER

By Lynn Harris

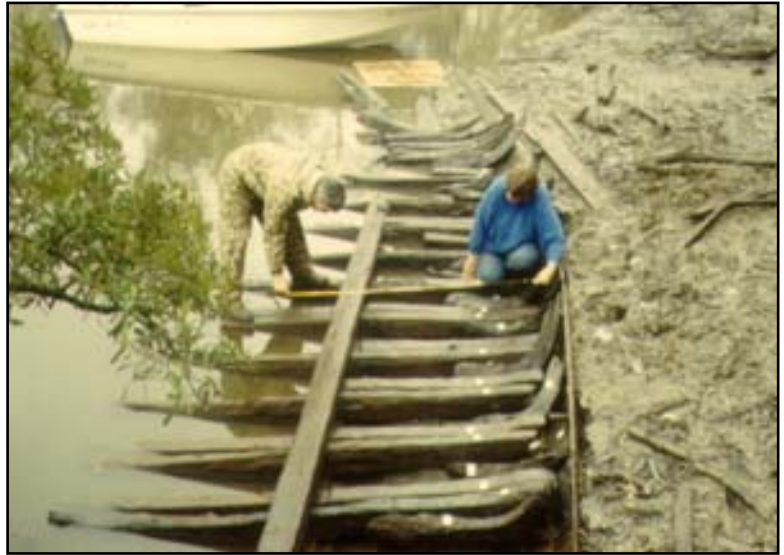
Figure 1: Eddie Weathersbee and Dee Boehme record timbers of sailing vessel on banks of Ashley River (SCIAA photo).

The framing pattern on the sailing vessel consisted of sets comprised of a floor timber and two first futtocks on either side fastened together laterally with metal bolts. The very square 90 degree rise of first futtocks, almost resembling standard "knees," is unusual compared to the earlier nineteenth century vessels the Institute has recorded. This was evidently a very boxy-shaped boat. The floor timbers and a disarticulated keelson both displayed distinctive slots cut to fit snugly together, locking the floor timbers into place.

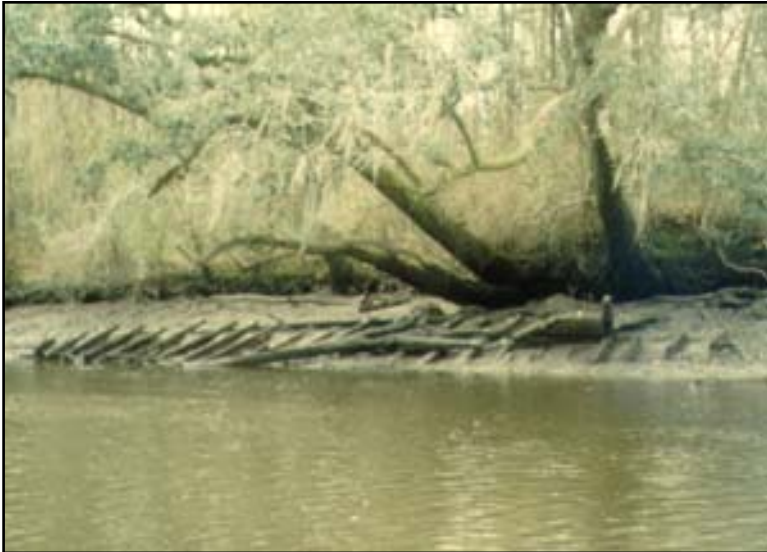
Figure 2: Shipwreck along shoreline of river (SCIAA photo).

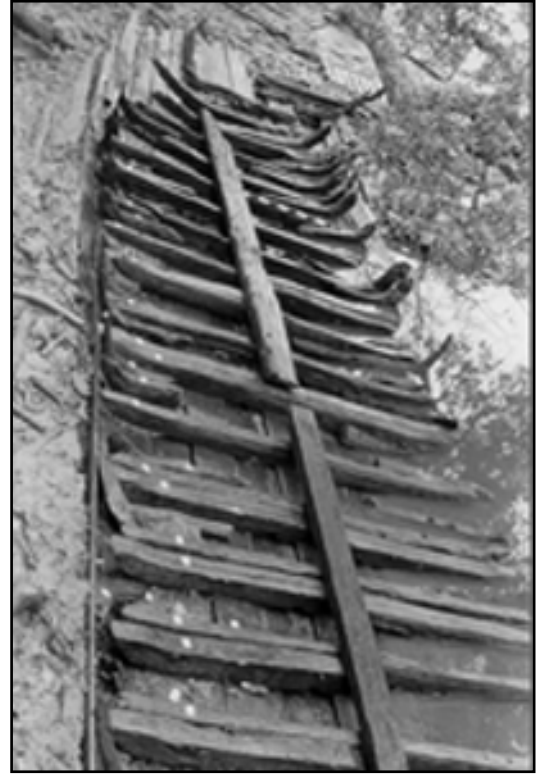
Figure 3: Longitudinal view of shipwreck (SCIAA photo).

The three vessels that were documented include a tugboat (with a length of 20.62 meters and beam of 6.45 meters), a motorized wooden vessel (length 17 meters and beam 2.82 meters) which is probably a sailing ship, although sections of the keelson are missing so there is no evidence of maststeps and rigging arrangements. For particulars on the tugboat, see *Flotsam and Jetsam*, May 1995 issue.
